# Elevating Work Platform Transporting Incidents

## Elevating Work Platform Transport Incidents

## Case Studies

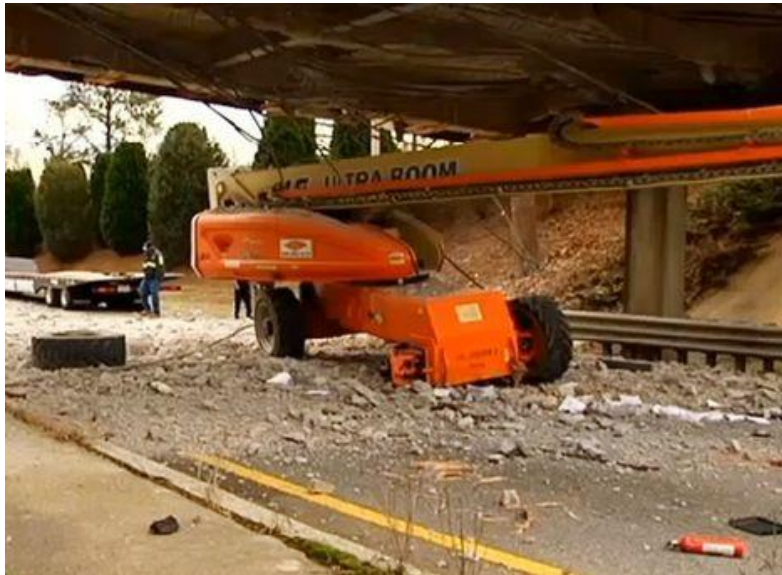
*The damage on the boom lift is surprising light given the impact*

The incident occurred last Monday near Spartanburg when a JLG Ultra Boom, owned by Ahern Rentals and transported by a private contractor, passed underneath the bridge at speed, ripping the lift off the trailer and moving the deck.

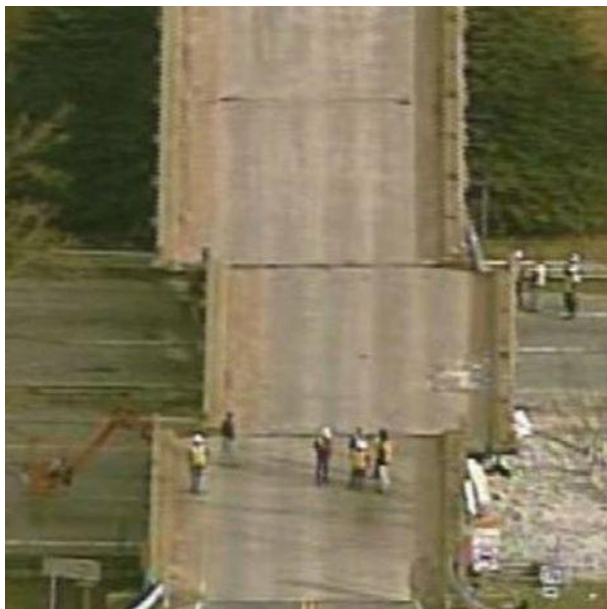
*The bridge deck was moved over 1.5 metres*

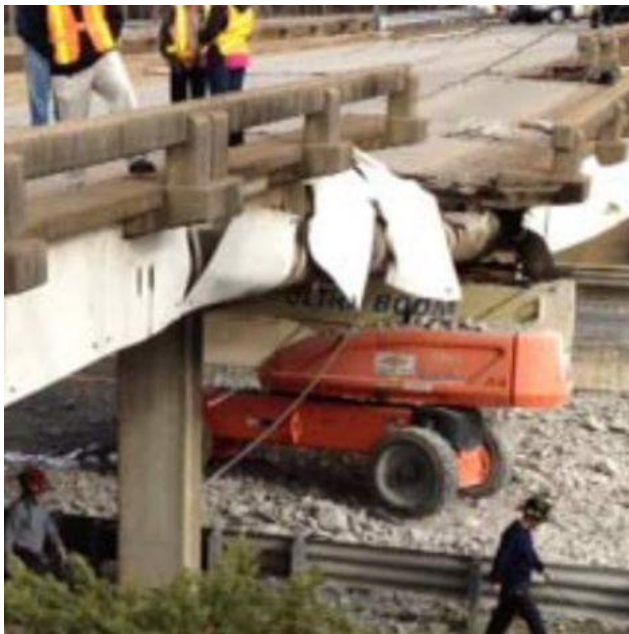
*The bridge was damaged beyond repair*

The bridge section has now been removed and the Interstate reopened. Police said that the driver of the tractor-trailer has been charged with discharging his load on the highway.

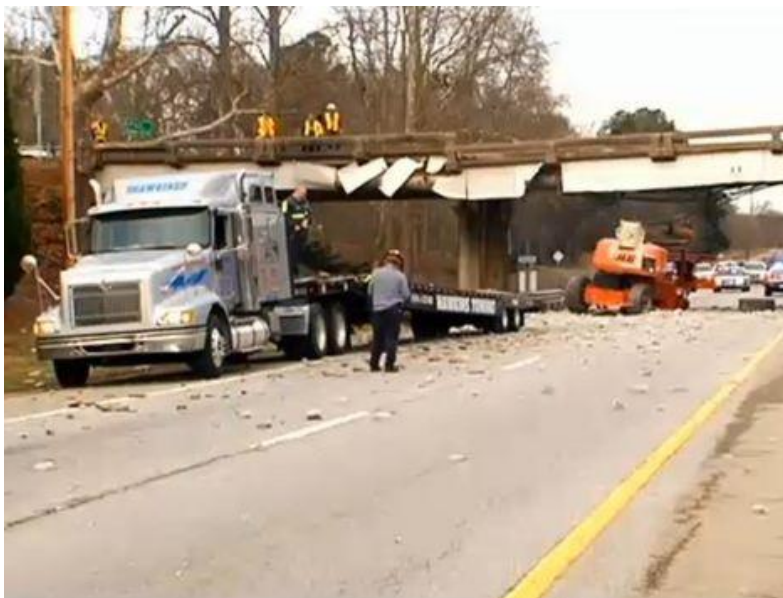
*The truck looks as though it was from a third party hauler*

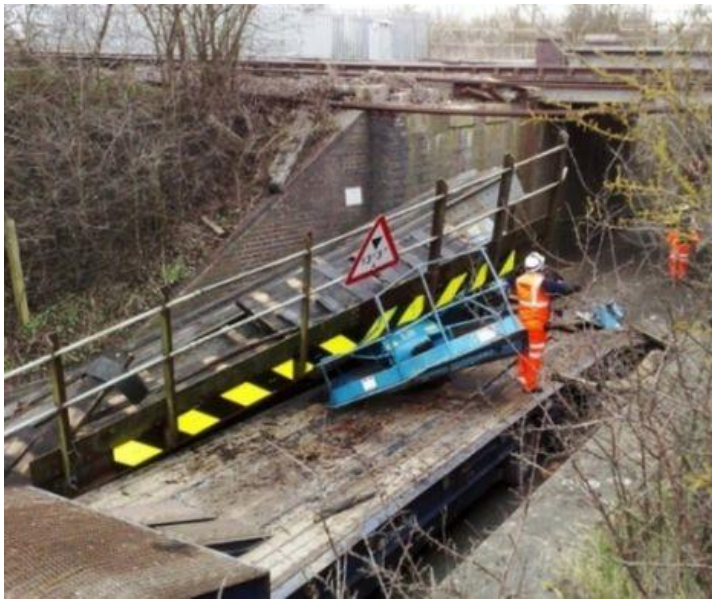
*The truck caught part of the bridge as it came out*

This looks like a case of a hanging obstacle that the driver missed, the Genie boom has an 9ft overall height, so in order to catch a 13.3ft (4.0m) bridge the trailer bed had to be 4ft 3 inches high (1.3 metres), which it clearly is not. The fact that it passed beneath the first bridge and then the first half of the second bridge would also seem to confirm this.

However this incident does raise the importance of knowing the overall height of the load and comparing it with the bridge height before passing underneath.

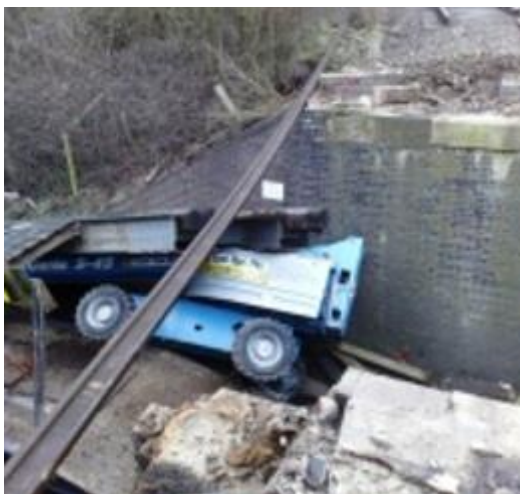
*The boom appears to have been stowed correctly*

Easi-Uplifts says that it is unable to comment apart from confirming that the accident occurred, that the machine was correctly stowed on the trailer and that the driver had passed underneath the bridge, which is close by the company's midlands depot, on many occasions before with no problem.

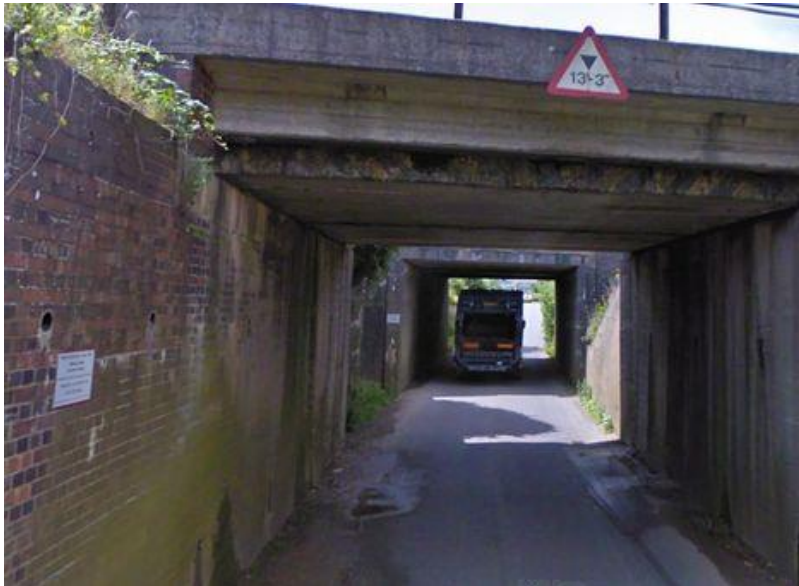
Locally there were suggestions that the bridge which came down had been subjected to earlier damage that might have reduced the clearance height.

*The Fenny Compton rail bridges prior to the accident*

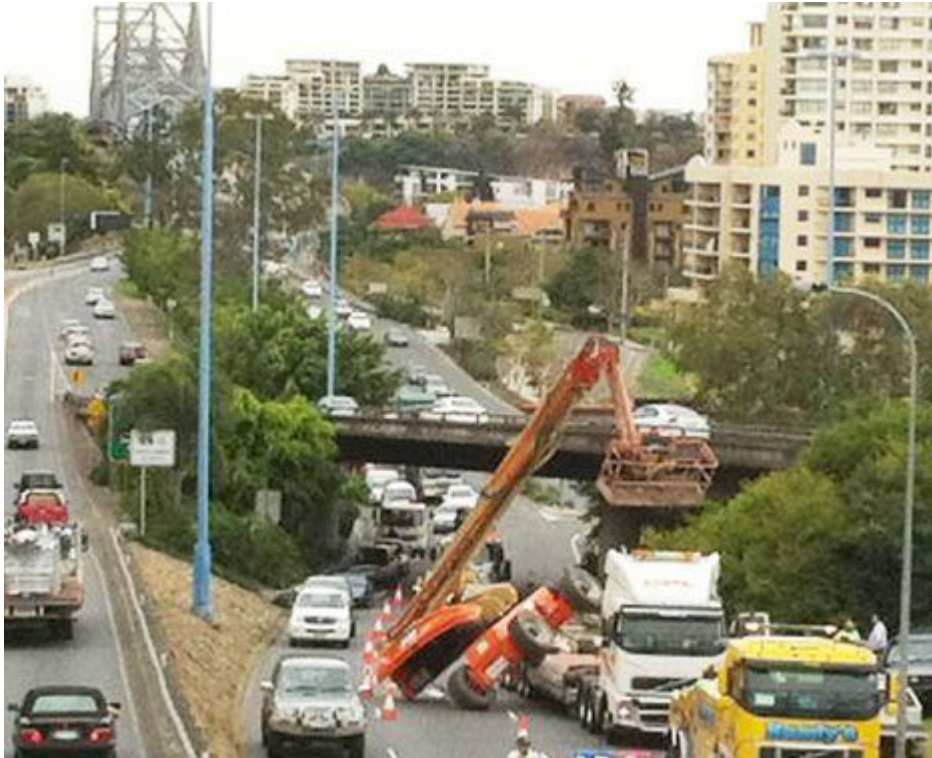
*The boom lift was just high enough to catch the bridge*

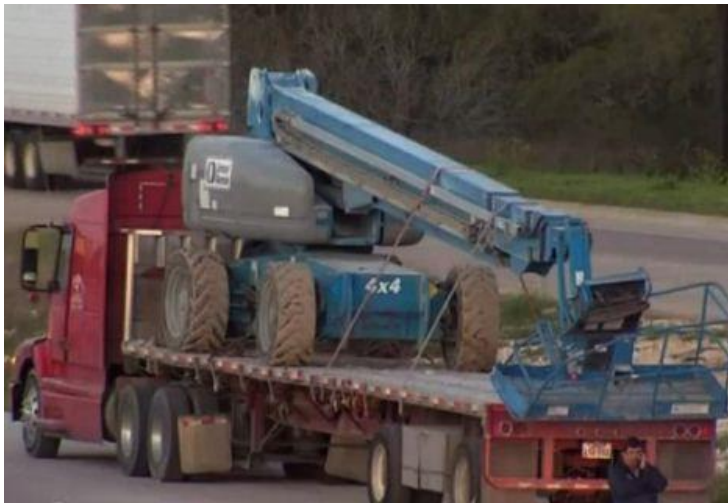
According to police the truck, carrying a Genie boom owned by United Rentals on a flatbed trailer, struck the beam of the bridge, which is currently under construction on Interstate 35 in Salado, Texas to the north of Austin.

*The boom lift was only lightly damaged but the incident it caused was major*

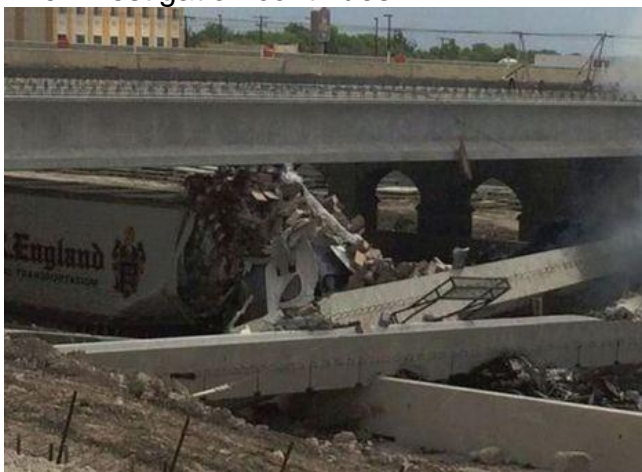
*The next truck caught up in the damaged beam and pulled it down*

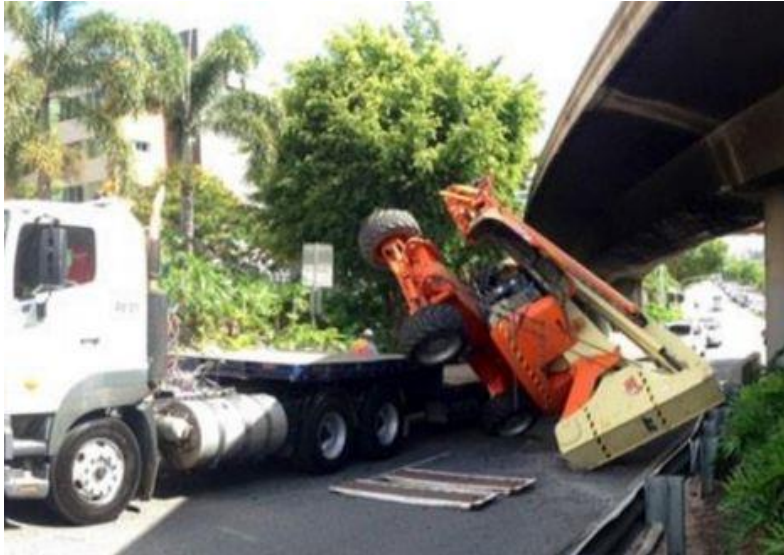
*The boom struck the overpass as it went under*

Photos indicate that the riser on the JLG – possibly an 800 series articulating boom – was not full stowed, raising its height by a critical 200 to 300mm or so. The incident occurred as rush hour traffic was getting underway, causing considerable delays.

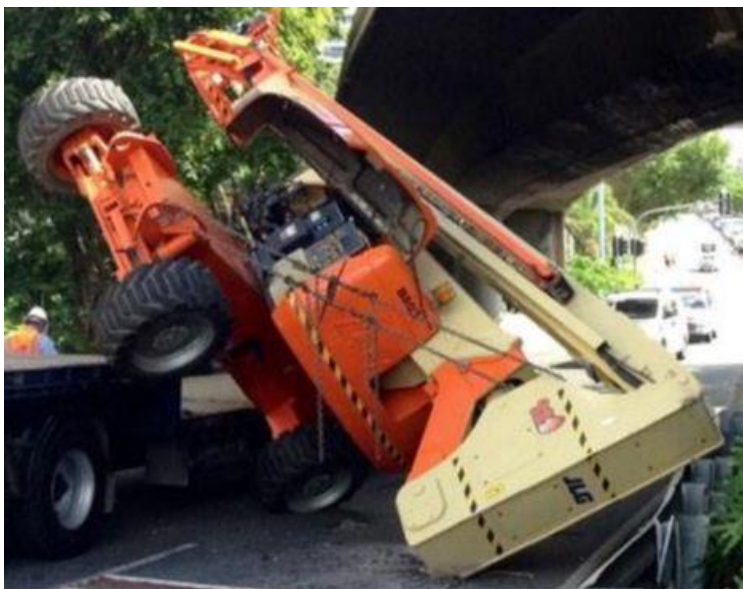
*It looks as though the riser was not fully lowered*

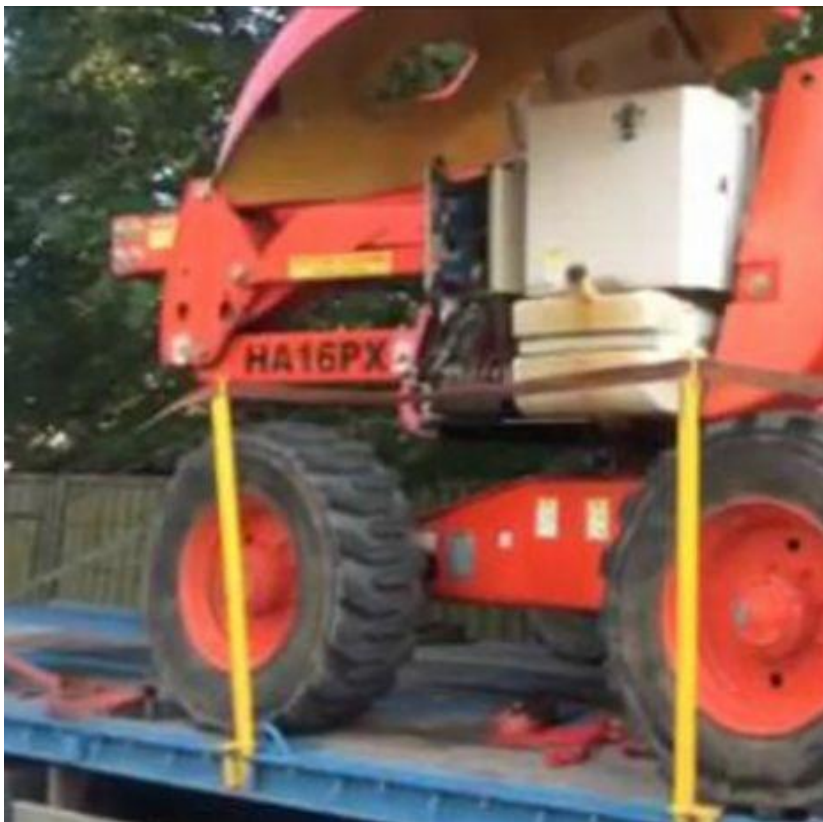
Photos we have been sent seem to show that the boom, jib and platform were properly stowed which would mean that the jib knuckle which protrudes slightly caught on the underside of the bridge and jammed sufficiently to pull the fly section out.

*The machine remained firmly on board*

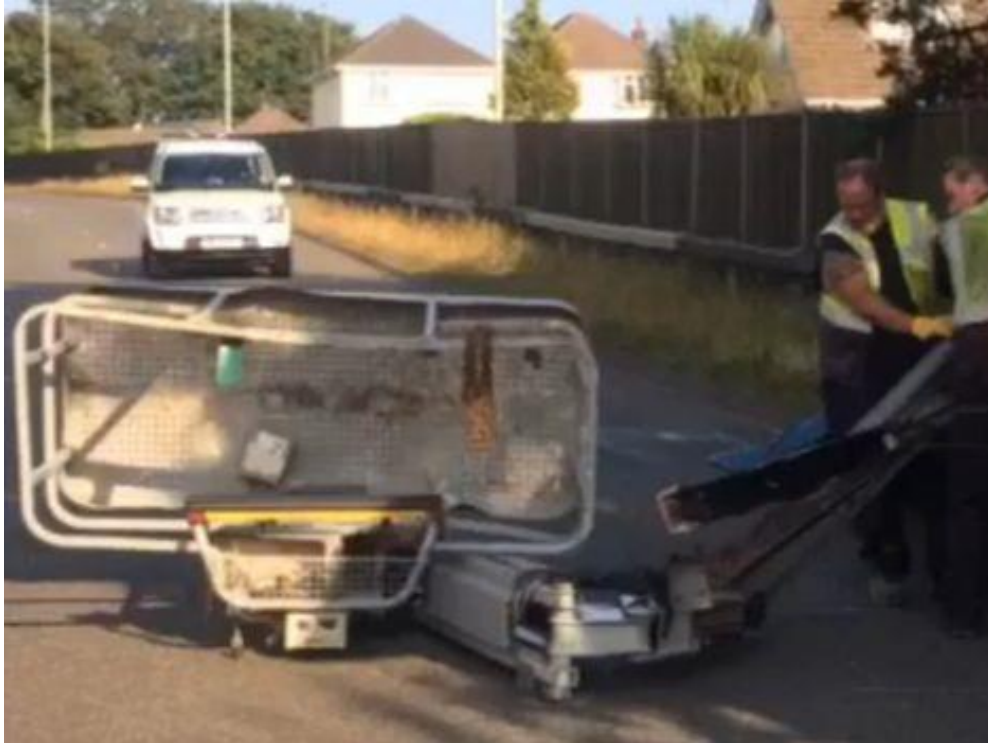
We understand that the boom section, jib and basket after striking the road remained attached to the machine via its hydraulic hoses and cables. The truck pulled up and help was called to load the section back onto the truck. Meanwhile the road was closed while the bridge was checked and the road surface patched. Thankfully no one was injured.

*The boom section, jib and platform are recovered under the eye of a police car*

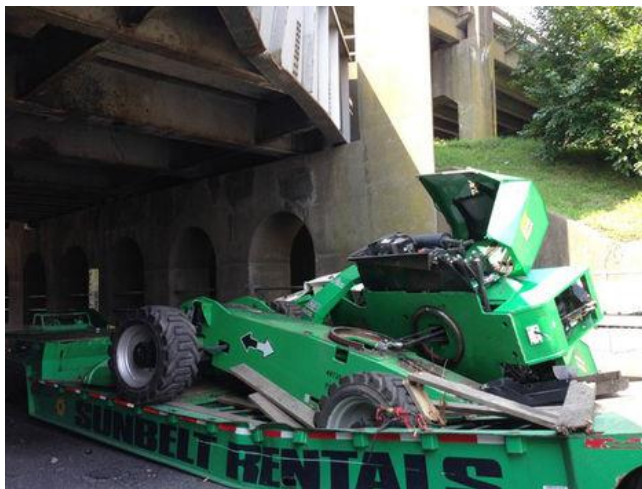
The unit, a relatively new JLG, is owned by Sunbelt Rentals and is the delivery rig. The driver suffered from minor injuries in the incident. The bridge was damaged and the road was closed for some time while a large oil spill was cleaned up and the truck removed.

*The superstructure is ripped off*

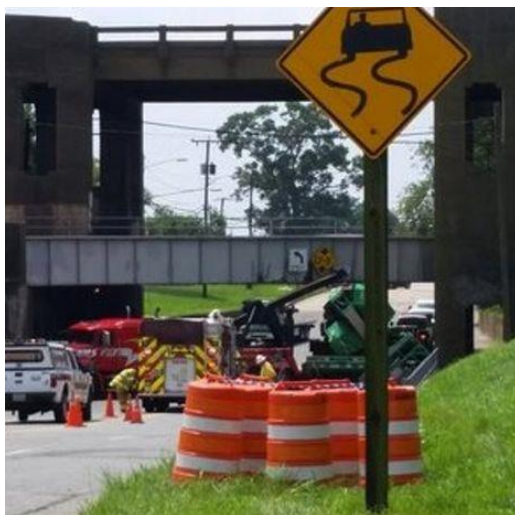
The bridge is supposedly over four metres high (13'8"), which should have provided sufficient headroom as the stowed height of the machine is around three metres.

*The lower bridge is supposed to have a clearance of almost 4.2 metres*

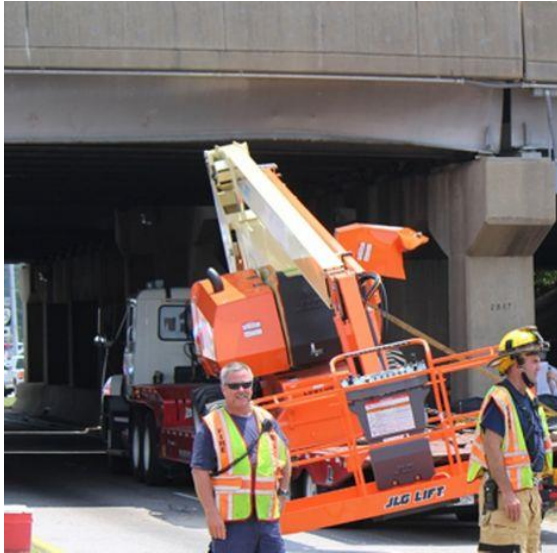
*The scene after the incident as emergency services look to recover/remove the truck*

The bridge/overpass sustained some damage to the large I-beam it smashed into but the roads were reopened later in the day. No one was hurt in the incident. The riser knuckle on the boom lift, a JLG 800AJ, was simply too high to pass under the bridge, possibly due to not being fully stowed? The impact appears to have broken at least one of the wheel axles.

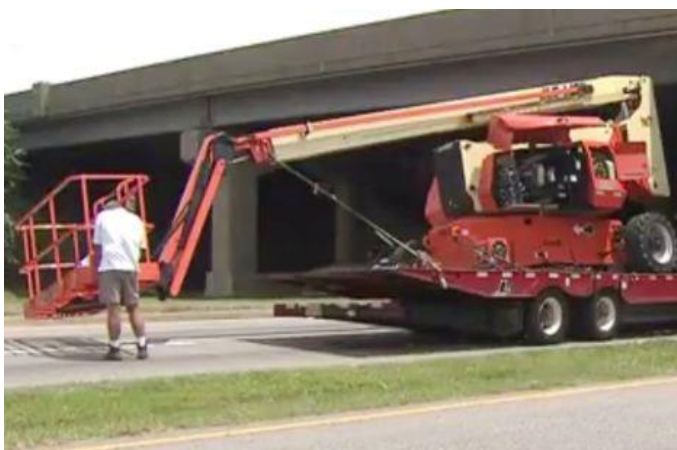
*At least one of the wheels broke off*

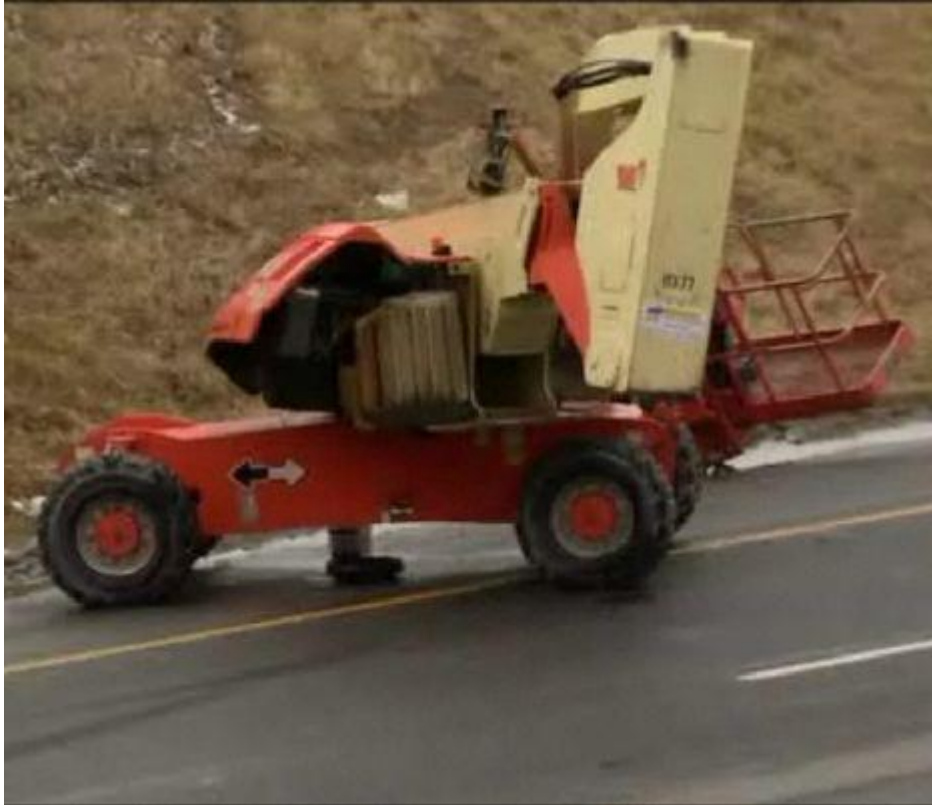
*The lift clearly suffered a serious impact*

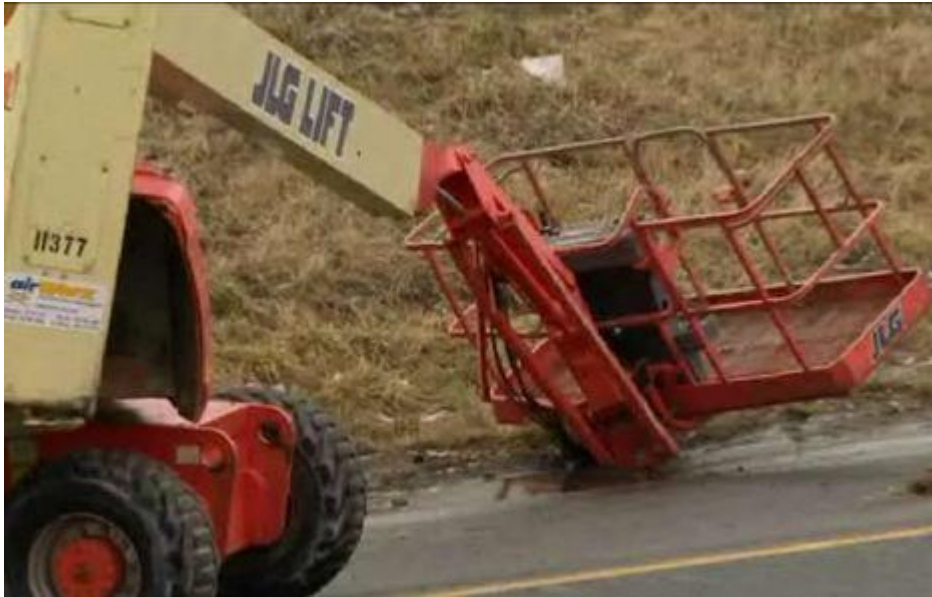
*Repairs will be costly*

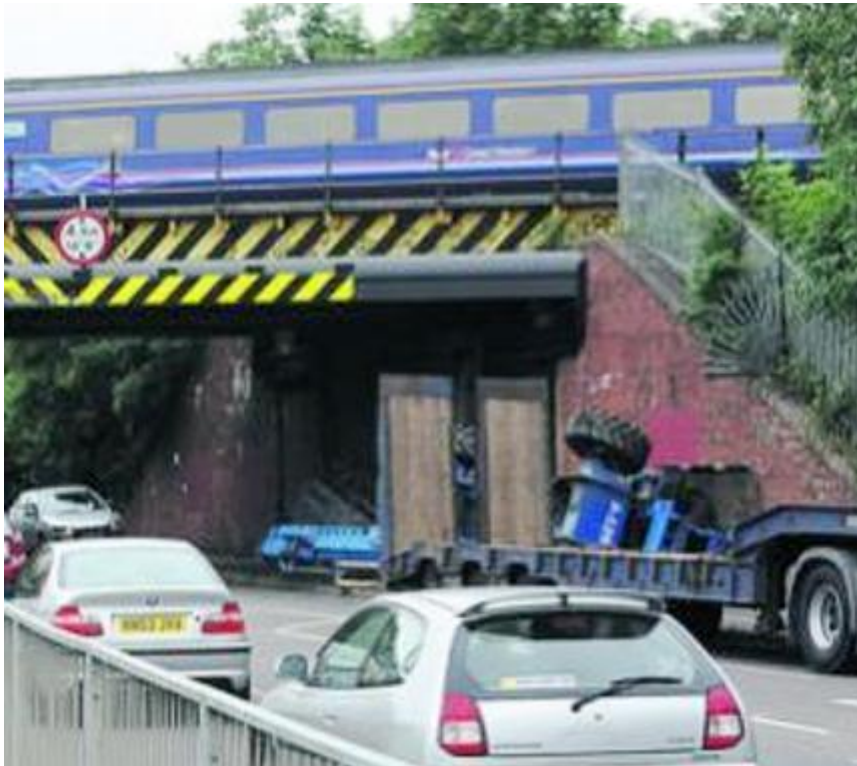
No one was hurt in the incident and damage appeared to be limited to the boom lift. There was however considerable disruption to traffic while the unit was recovered from the scene.

*The scene yesterday*

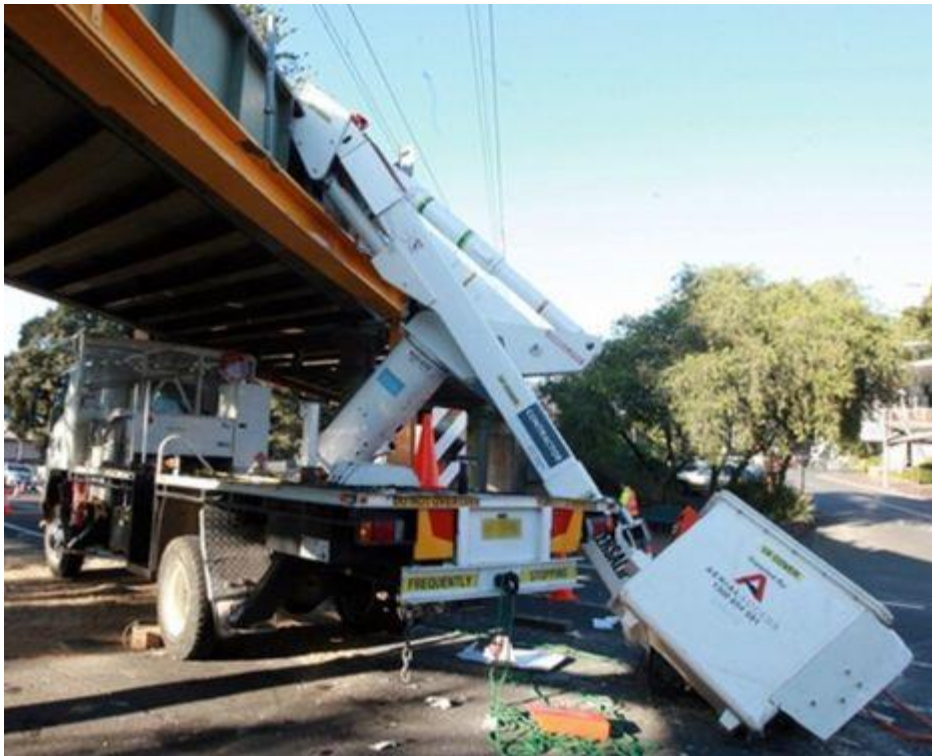
No one was hurt in the incident but the lift and the truck will need some work. The rail bridge is not believed to have been badly damaged but RailCorp sent an engineer out to check it.

*The truck mounted platform's boom collided with the bridge in Kiama, New South*

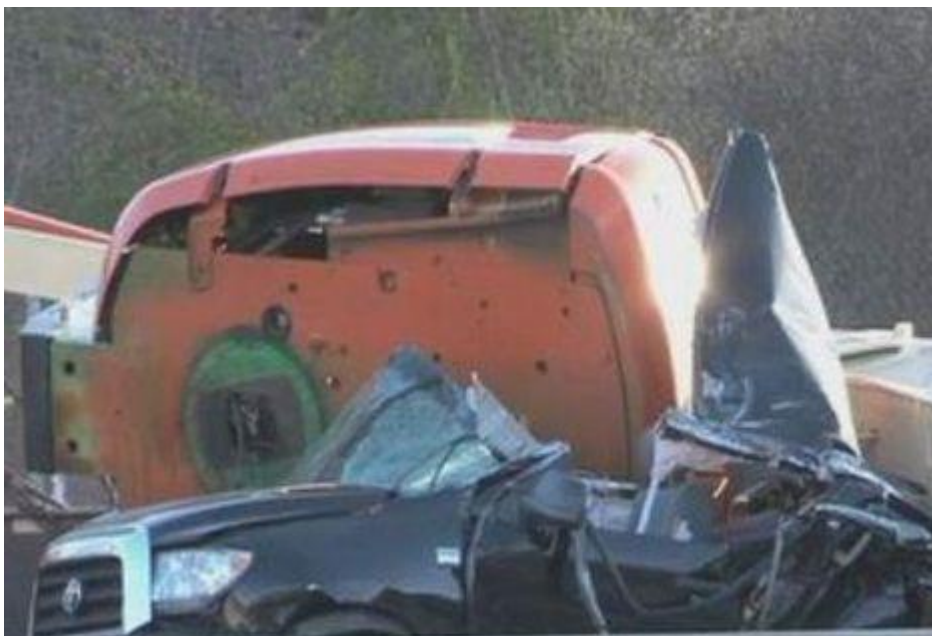
*The superstructure crushed the vehicle, but the driver escaped uninjured*

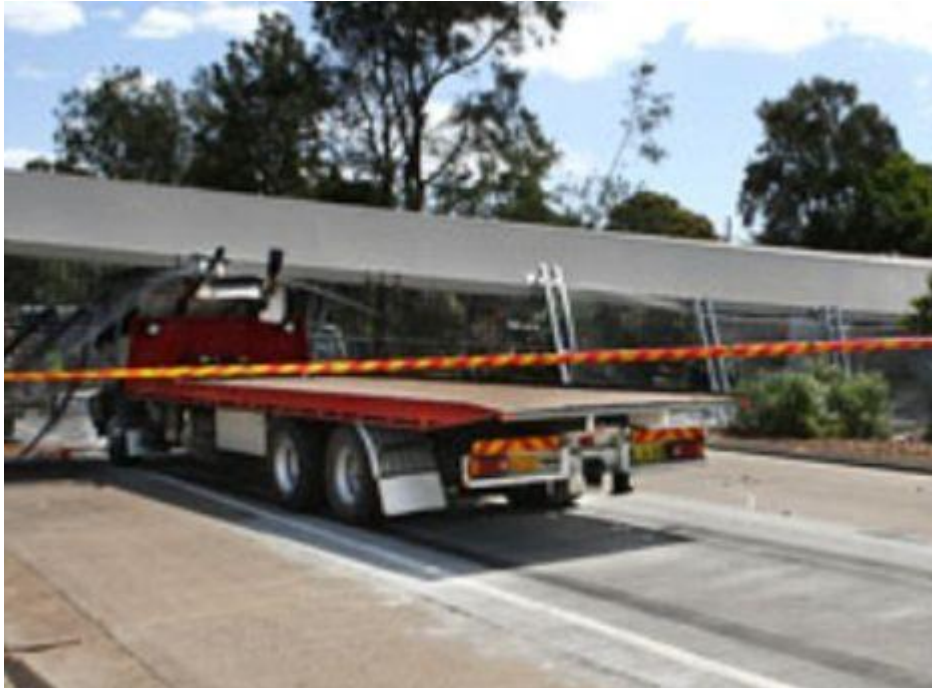
*The footbridge came crashing down onto a car and a truck*

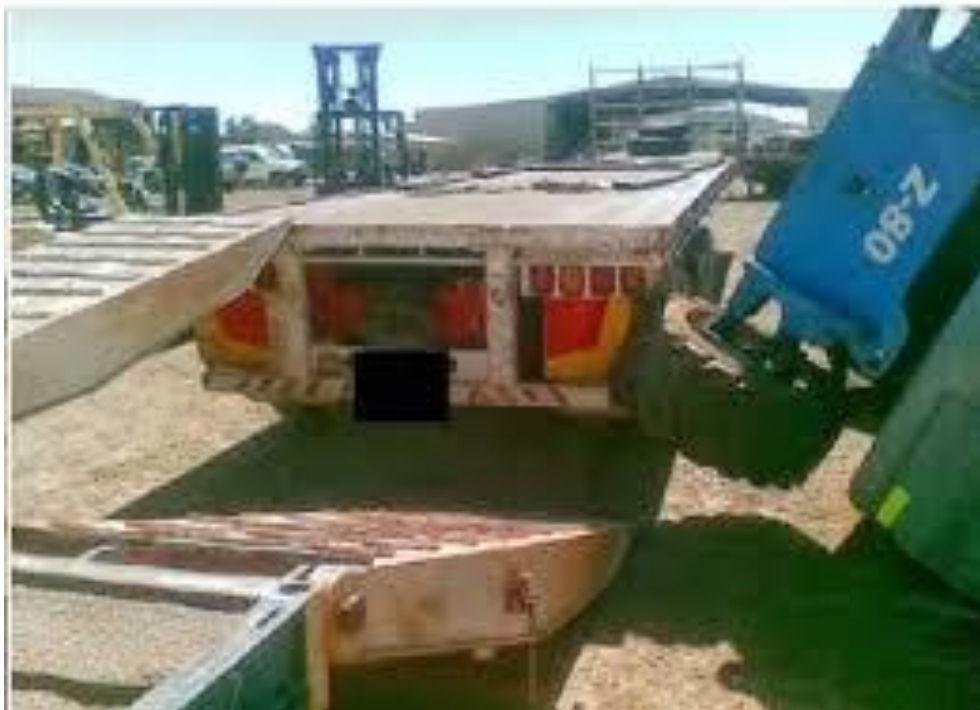
Local police said, "They were fairly high off the ground and the ramp that was used to drive the platform across failed and caused the elevating work platform to tip. The deceased had fallen out as a result and suffered injuries from the fall."

We understand that the man was not wearing a harness.

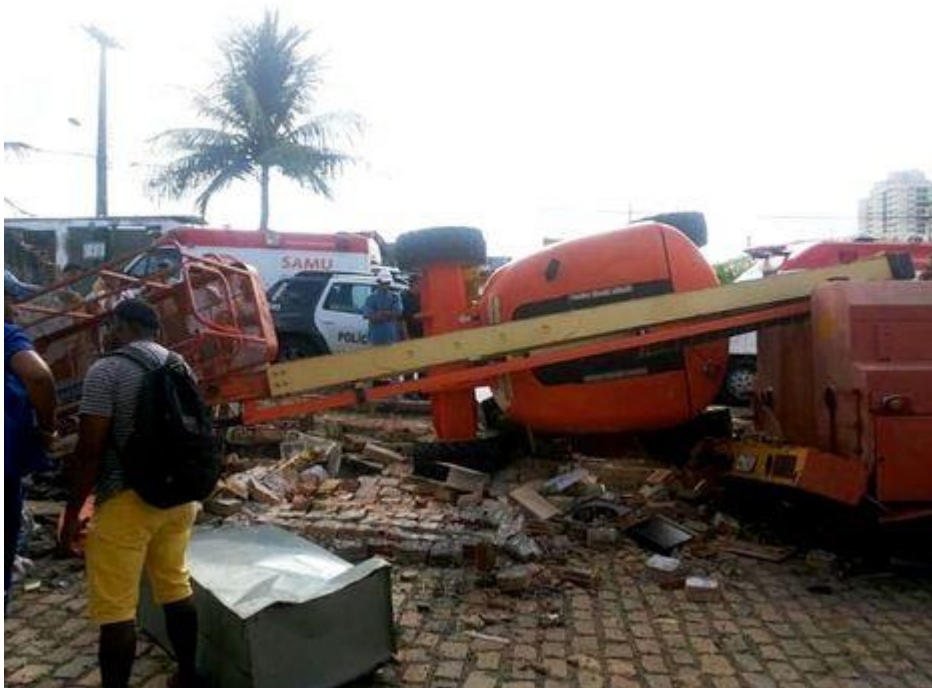
Details on the incident are limited; however it appears Joaquim Carneiro Bastos Neto, 48, was loading the JLG boom lift on to a truck at the yard of a rental company when it slipped off the side. It is not known whether Neto was struck by the falling boom lift or whether he was thrown from the basket. He was declared dead at the scene.

*The overturned boom lift*

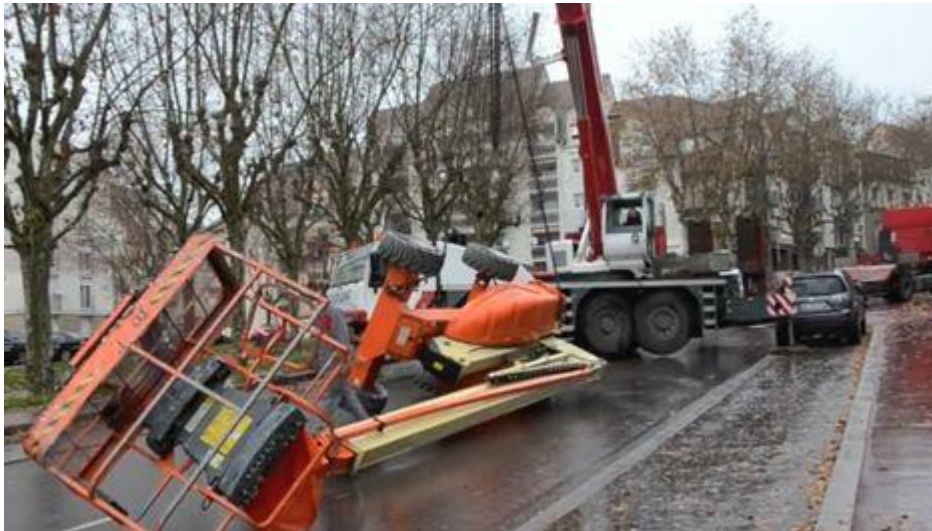
*The overturned lift - note the delivery vehicle in the background*

We believe that the lift, a 60ft JLG M600J owned by Medloc of Montceau Les Mines, was being unloaded from a trailer in the street when it slipped off the side and overturned, injuring the delivery driver/operator.

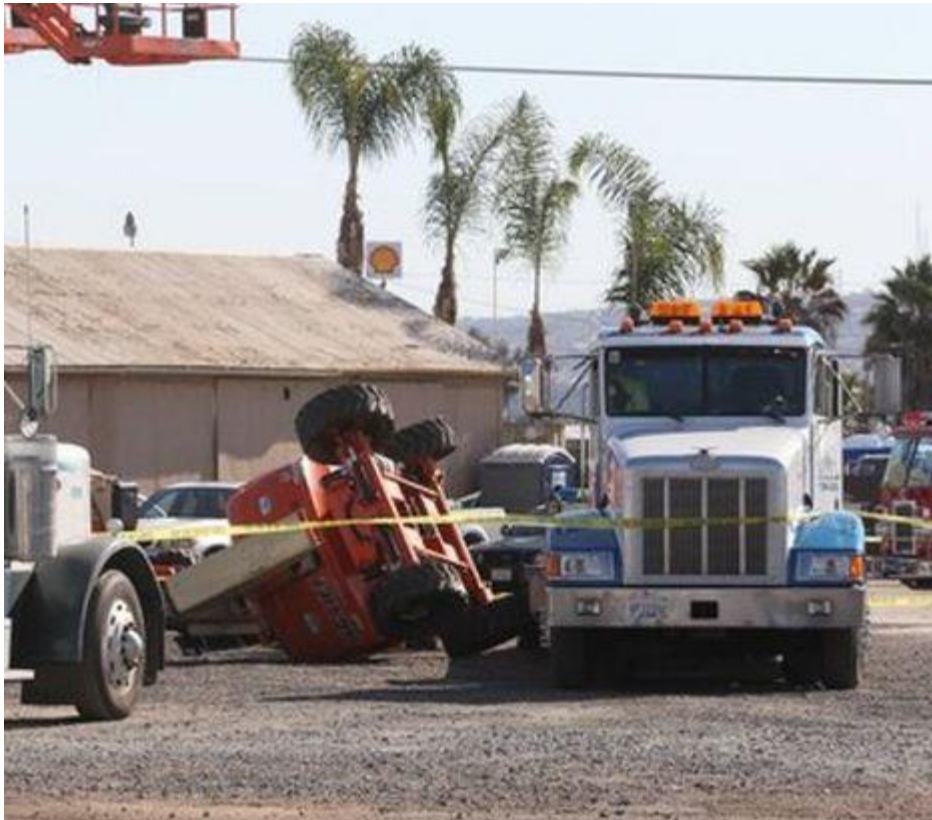
The incident occurred in the Palm City area of the city. The man, who would have been 59 on Saturday, landed on his head when the machine went over. We do not know if he was thrown from the platform or managed to hit his head from within the basket.

*The boom slipped off the side of the low loader*

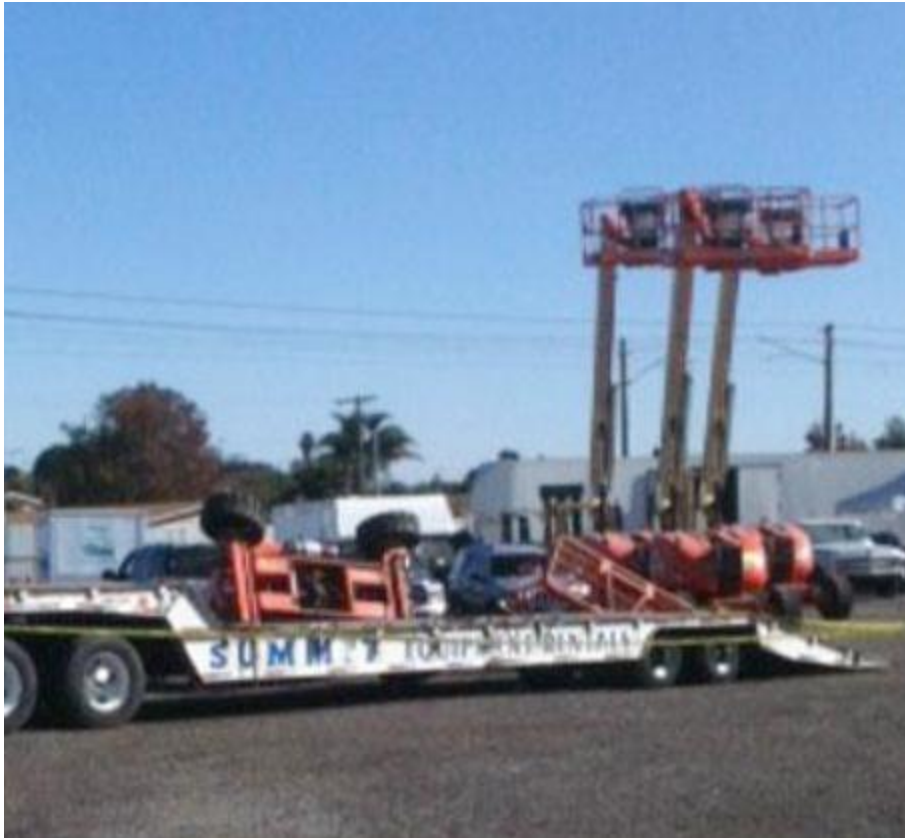
*The trailer was relatively low and was outside the rental yard*

Unloading aerial lifts – and other equipment from delivery trucks can be one of the highest risk manoeuvres if not carried out with due care. Too many drivers still refuse to wear a harness and short lanyard when unloading in spite of the high risk of serious injury or death from being catapulted from the basket.

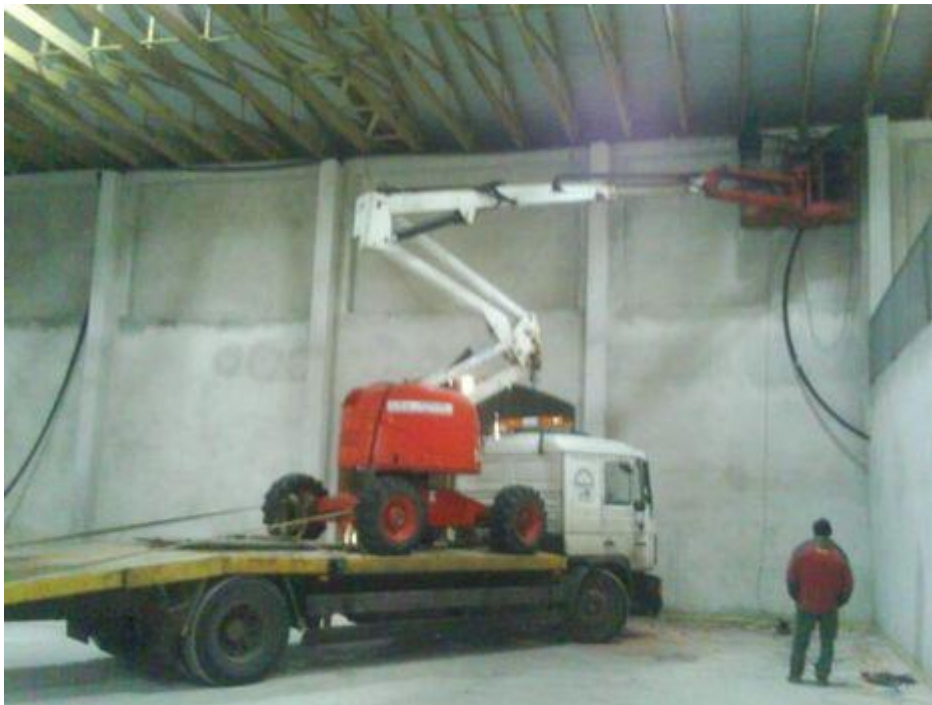
The worst thing about this one is not that it is intrinsically unsafe or that due to the trucks suspension the whole lot could go over and result in a fatality or two, the worst thing about this one is the fact was that this picture was found on the website of a company offering services that involve working at heights.

*Why bother unloading?*

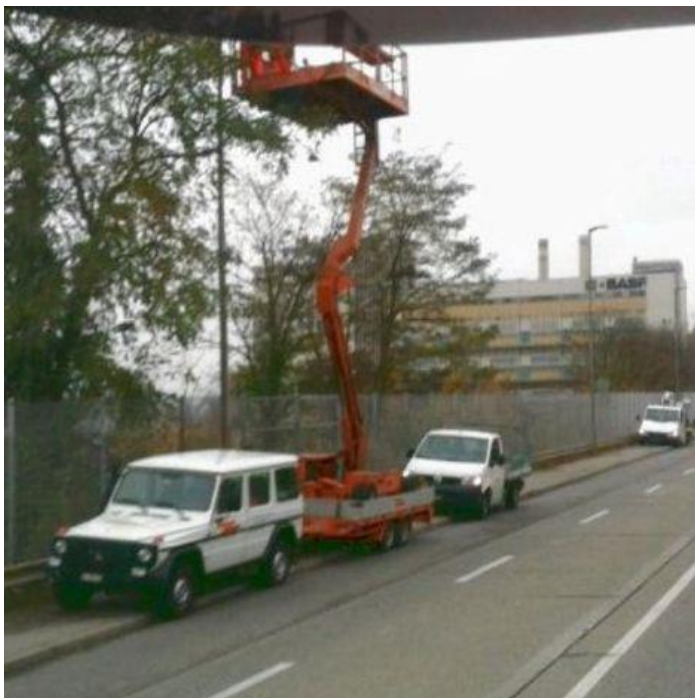
However when the user got to the run of trees he needed to work on he simply pulled his four by four and trailer up onto the kerb, started the lift and rather than unload it, proceeded to use it from the back of the trailer.

*The Speed Level trailer lift*

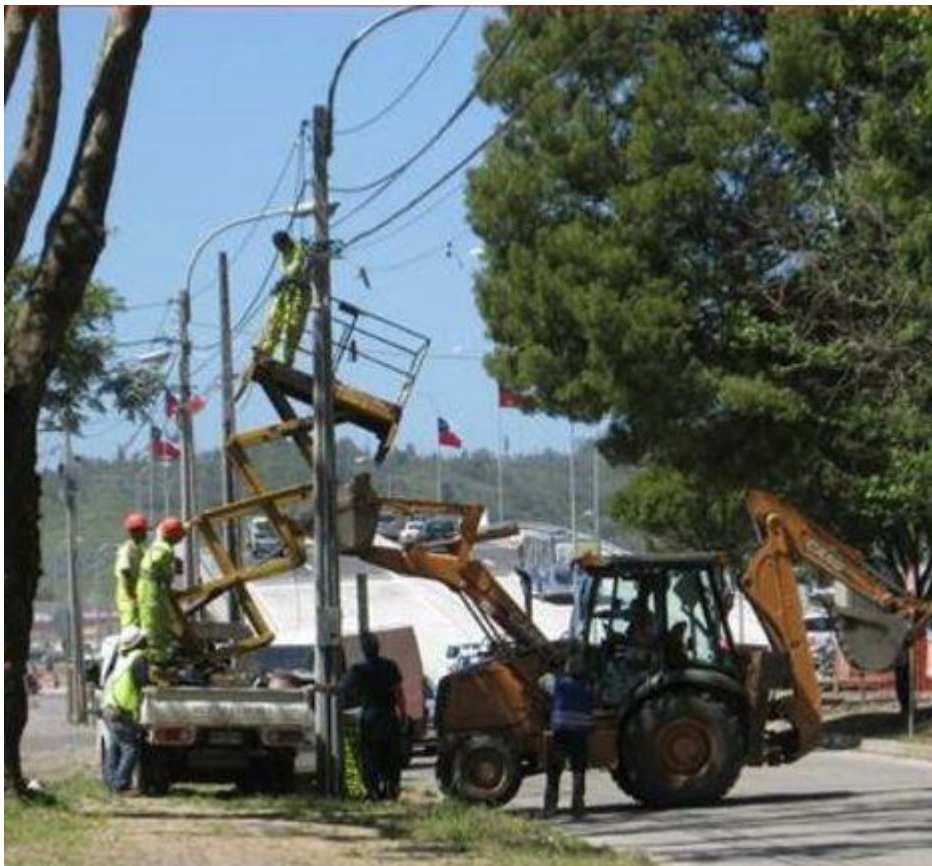
It seems that the men were working on overhead wires and, in order to reach them, used an old scissor lift on the back of a truck. However the truck is not directly underneath the point of work so for some bizarre reason that we cannot work out, the lift is extended at an angle and the team has brought in a front end loader to stop it falling over.

*We are not sure what is exactly going on here, but it does not look good.*

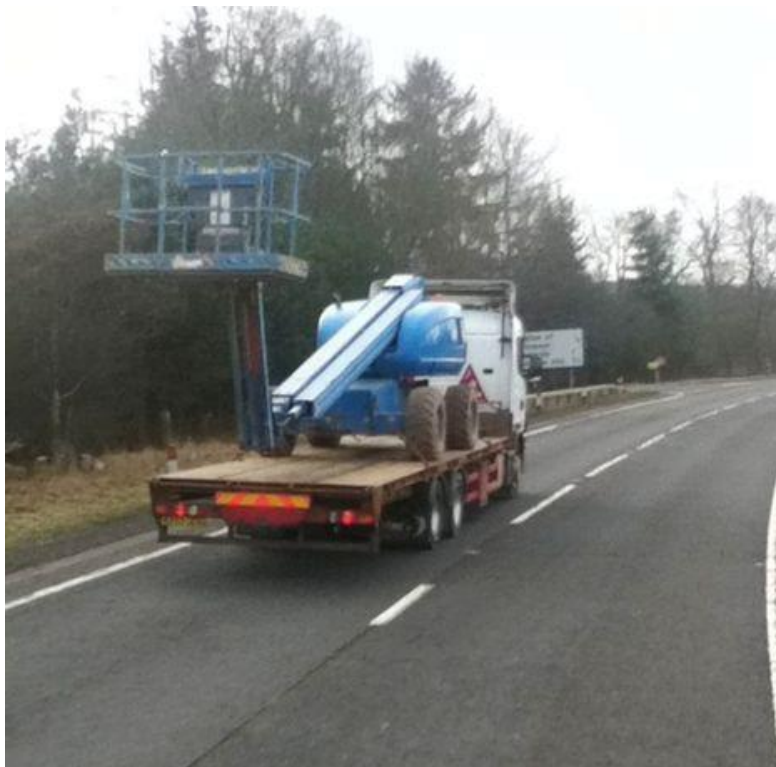
As our correspondent points out, the basket and articulated jib should have been tucked under and secured to the truck bed, as a) The superstructure is not restrained and b) The basket is the highest point on the vehicle. Possibly worst of all, in light of the above, the slew pin was not installed.

*Higher than truck, nothing to restrain it slewing over the side*

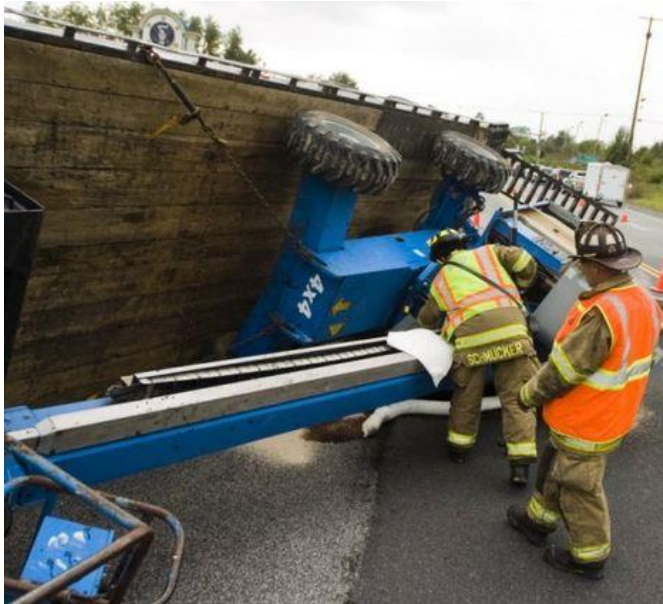
The boom, which looks to be a Genie S45 4x4, was certainly well secured and remained firmly tied down in spite of its 5.5 tonnes/12,000lbs overall weight. Fortunately no one was injured in incident although the road had to be closed while the recovery took place.

*The boom, which looks to be a Genie S45 4x4 was certainly well secured*

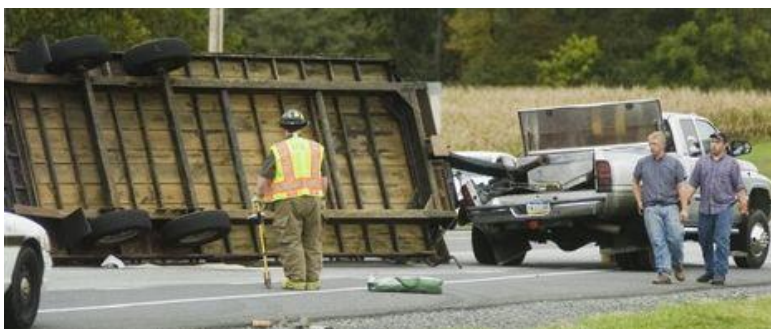
As to what caused the trailer, which was being towed by a pickup truck belonging to Danner's Bobcat Service, to overturn we cannot say. However a load of this weight seems high for the trailer. If a tyre had blown or the driver had been forced to swerve at high speed, the reaction could have easily built into a sufficient force to flip it.

*The road had to be closed while the recovery took place.*

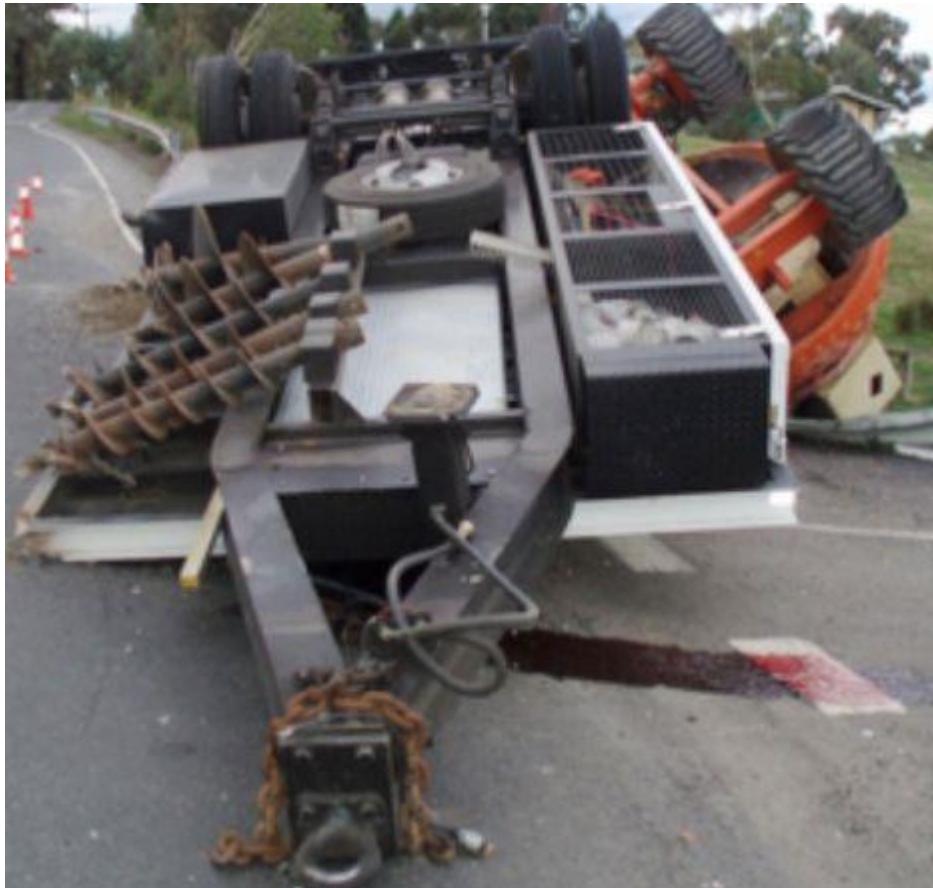
A 13 tonne trailer carrying a self-propelled boom lift overturned as the towing vehicle, reportedly a dump truck, took a corner too fast in the town of Plenty, Victoria North East of Melbourne in Australia.

*The overturned trailer and boomlift*

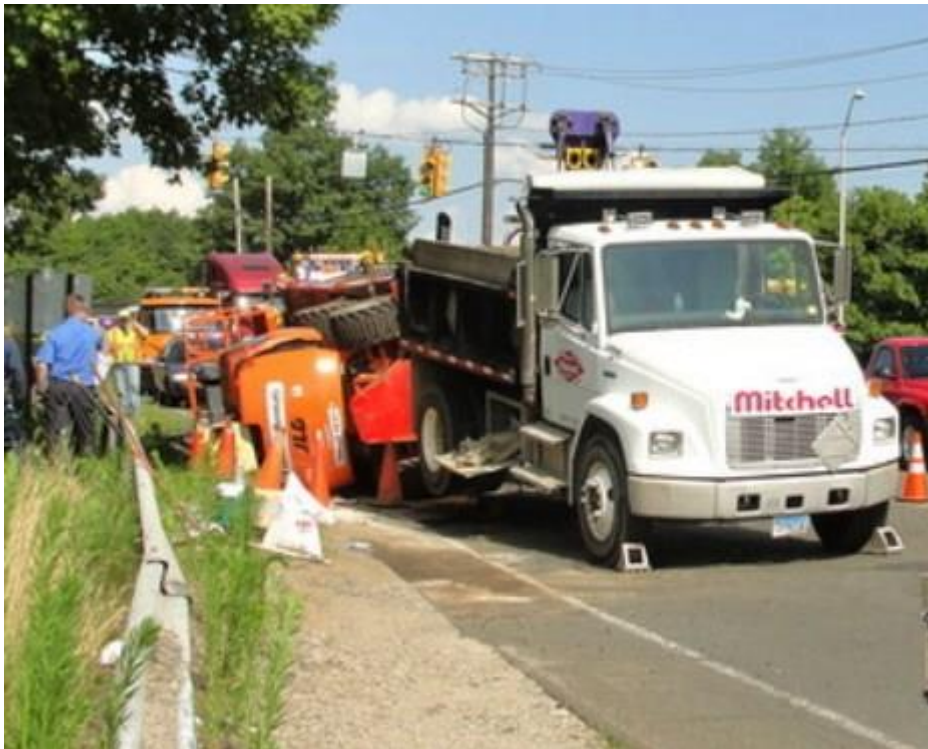
The dump truck, owned by Norbert Mitchell Company and driven by Thomas Cyr, 49, was turning left from the off ramp of Interstate 84 when the incident happened, dumping the JLG boom, owned by United Rentals onto the ground, spilling fuel and oil.

*The accident scene*
