# Elevating Work Platform Transporting Incidents

## Elevating Work Platform Transport Incidents

## Case Studies

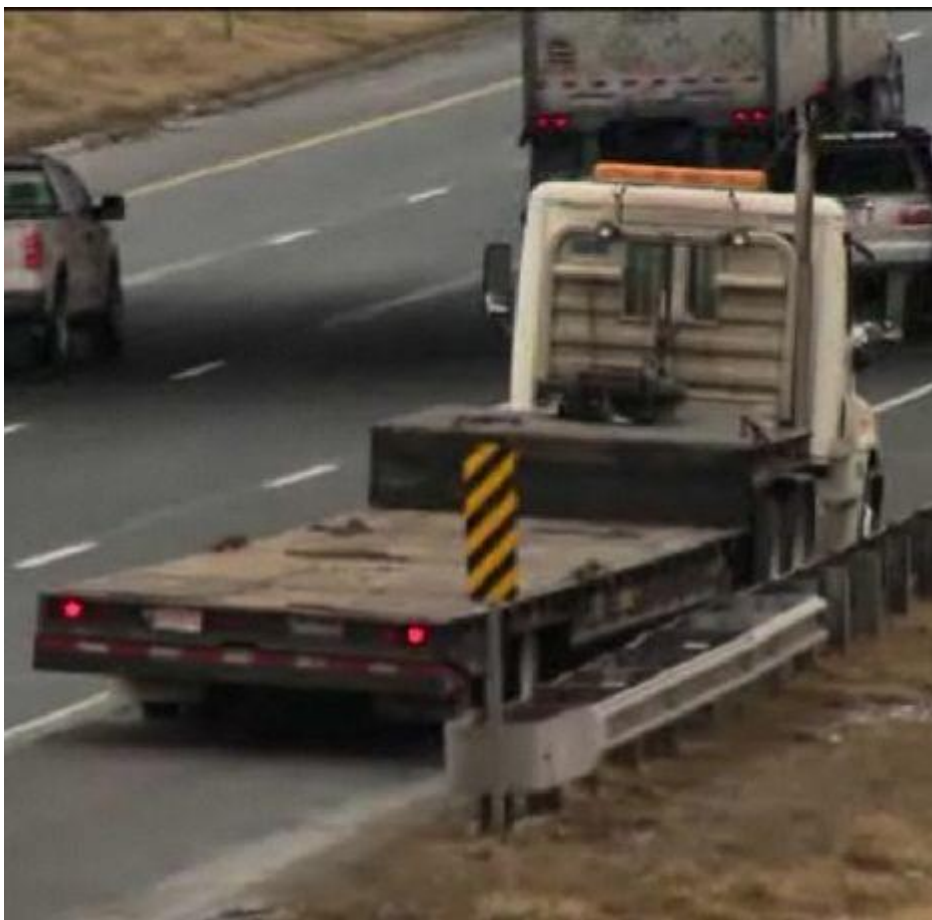
The lift looks like a JLG 600AJ and is owned by local company Air Worx, how it was high enough to strike the bridge is uncertain.

*The delivery truck*

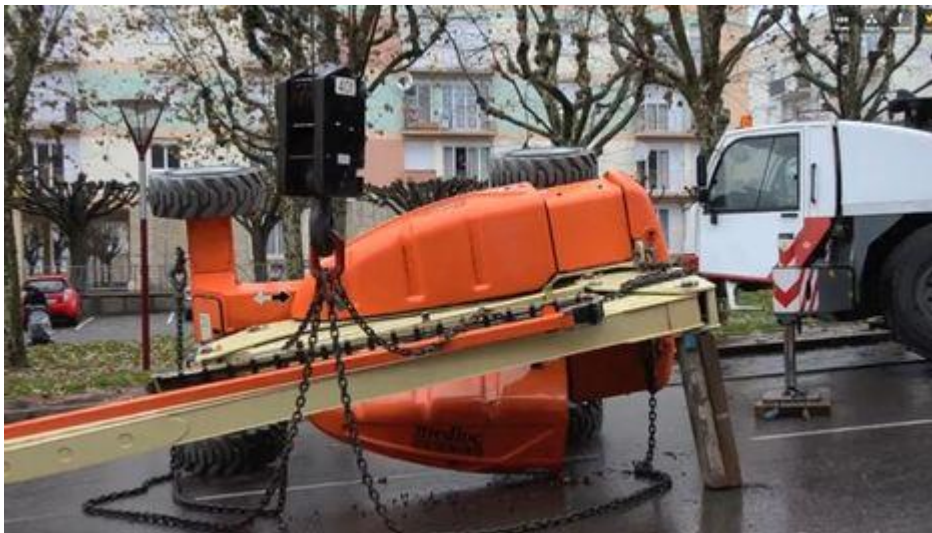
*Halfway up and blocked for re-rigging*

A three axle All Terrain crane was called in to recover the lift and proceeded to put the lift back on its wheels. The recovery was filmed and the video spotted by one of our readers who sent it in, alerting us to the incident. If anyone has any further details we would be pleased to hear from you. **To watch the video [click here](#).**

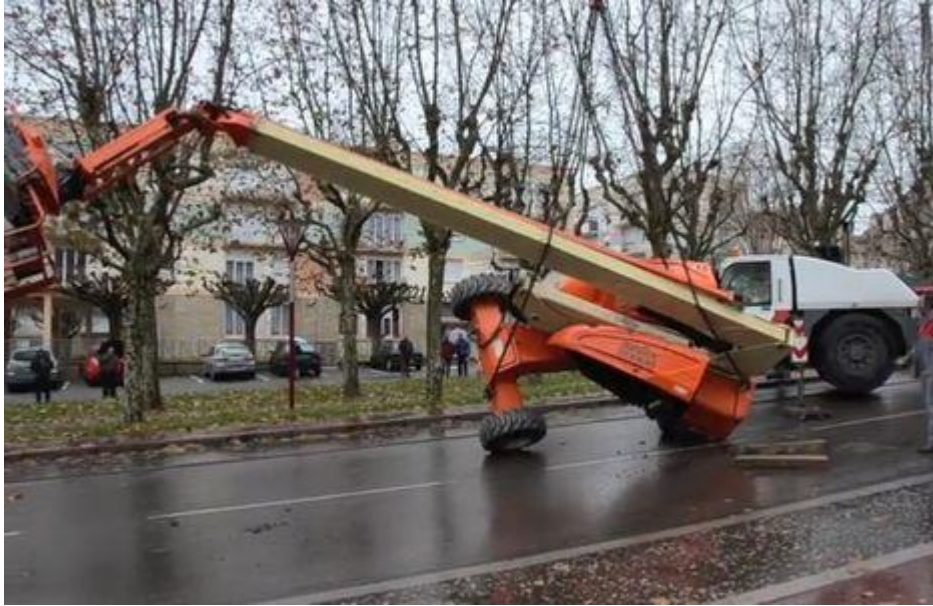
*Up she comes*
